**D.U.L.
LABORATORIES LTD**

Our Ref: DUL/29/07/20

**Tested panelled door
To EN 1634-1:2000
EN 13501-2:2007**

**All 3 tests were conducted to the principles of
BS EN1634-1:2014**

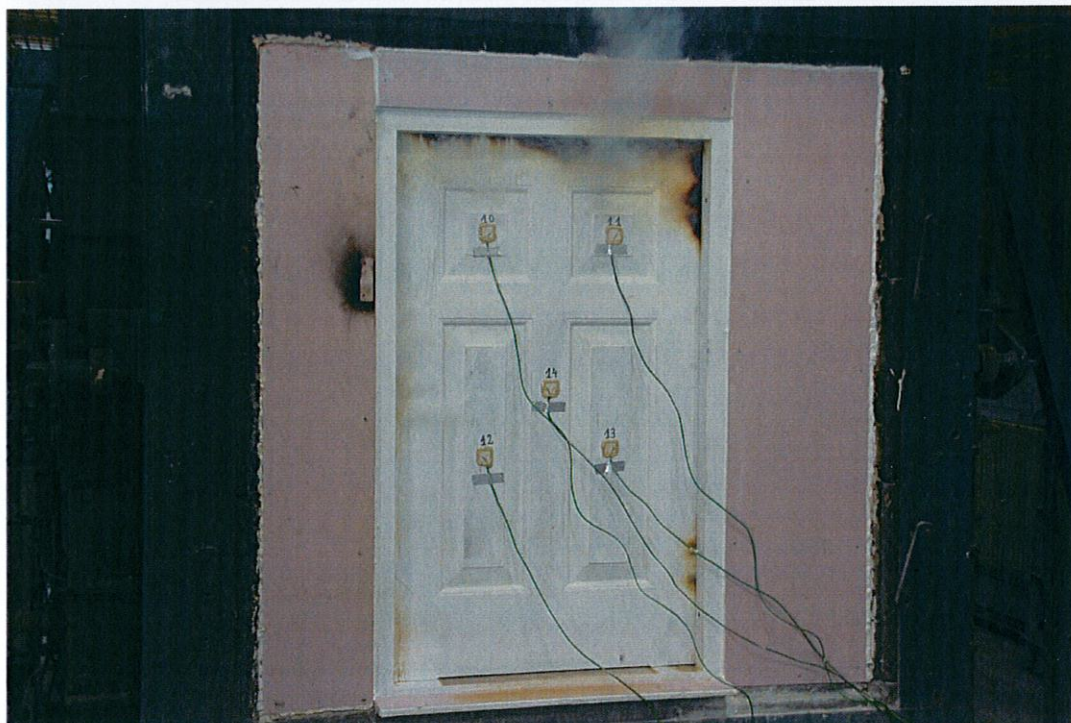
Image 4 – 3 minutes into the fire test. Discolouration around the edge of the door.

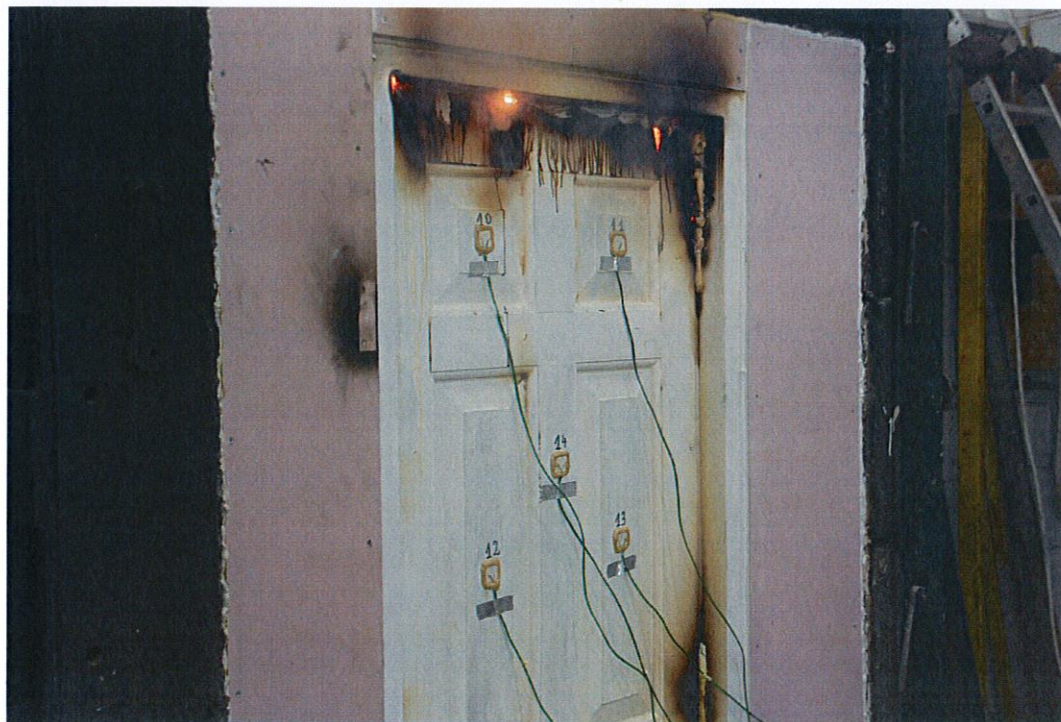
Image 9 – 43 minutes into the test. Test is terminated

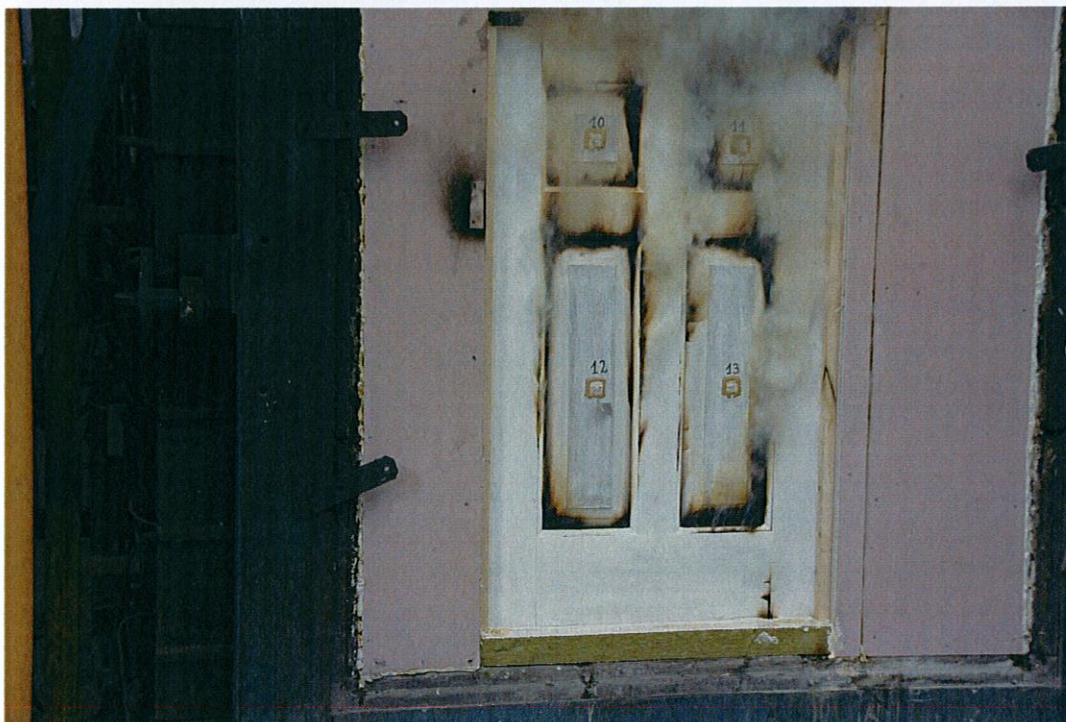
Image 10 – 66 minutes into the test. Test is terminated

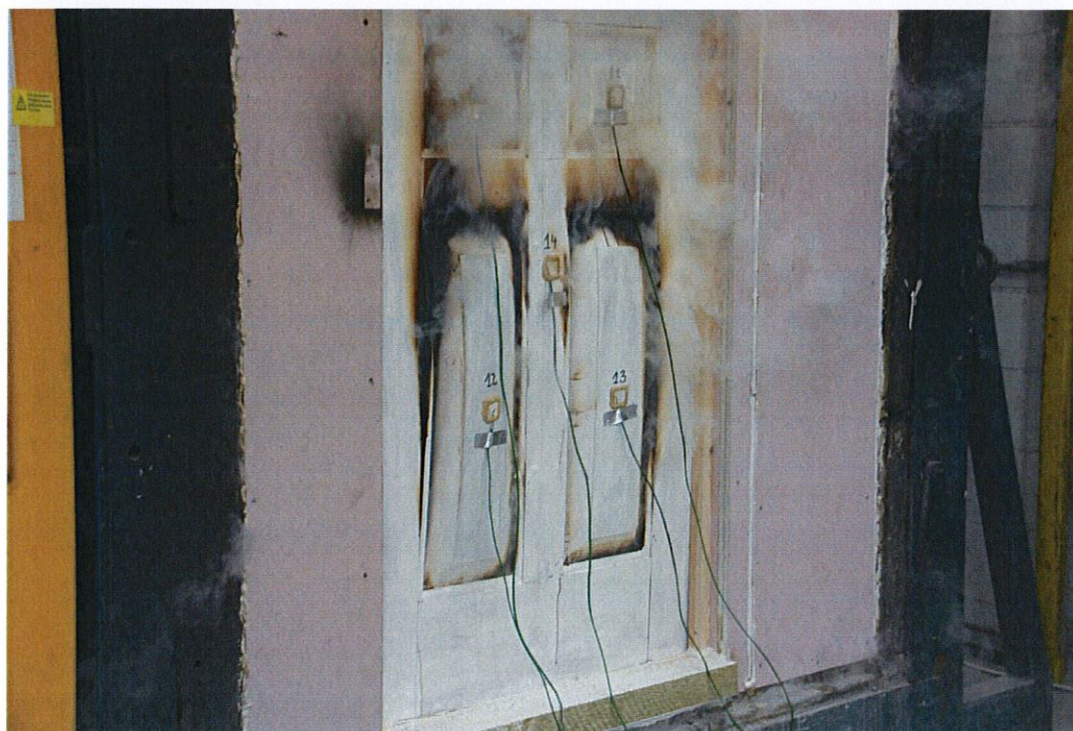
Image 10 – 78 minutes into the fire test. The panels start bowing outwards.

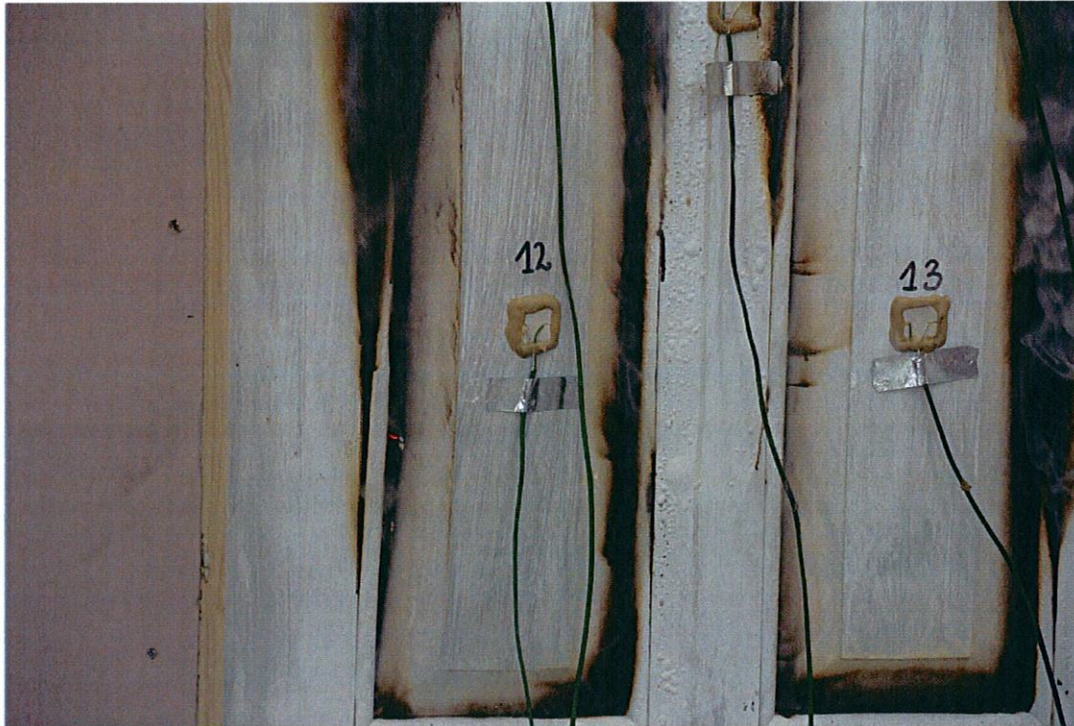
Image 11 – 80 minutes into the test. Glowing red on the edge of one panel.

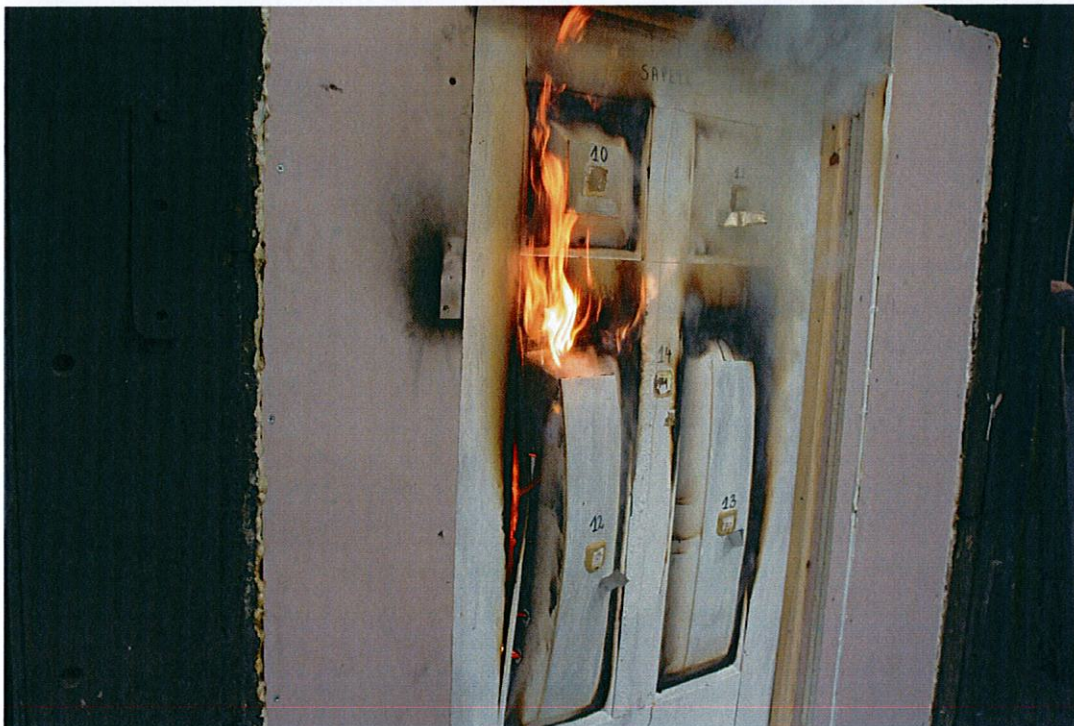
Image 12 – 82 minutes into the test. Test is terminated
